PROJECT REPRESENTATIVE'S DAILY REPORT

Pg. 1
Report No. 078
Date: 2014-12-09
Day: Tuesday

Project: Renovation and Addition to Tewksbury Town Hall

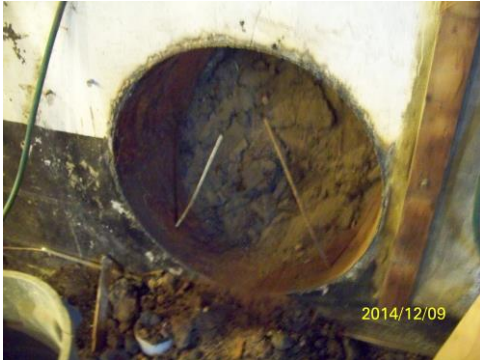
Photo showing the tank within the foundation wall on the south elevation, in the process of being bricked in.

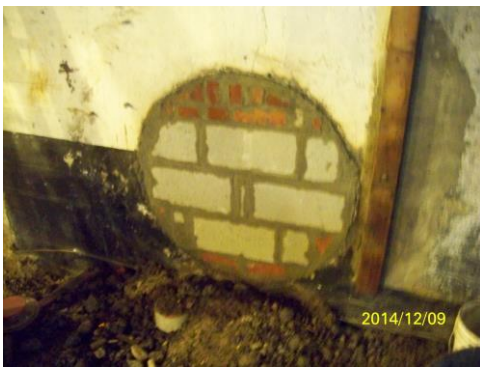
Photo showing the bricked in tank.

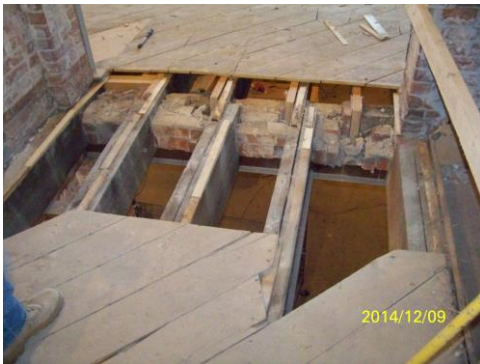
Photo showing a section of the subfloor in the process of being repaired. This is located in the hallway leading to the north wing.

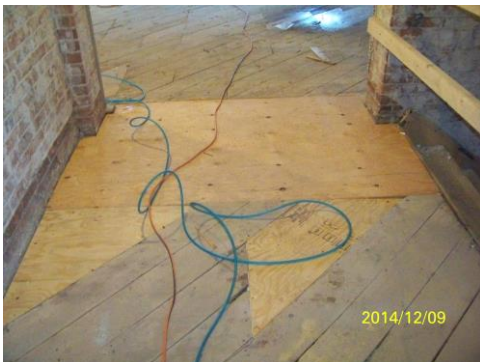
Photo showing repaired subfloor.

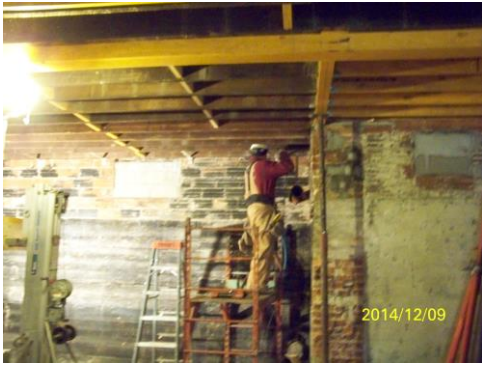
Photo showing carpenter continuing with the tie-back installation.

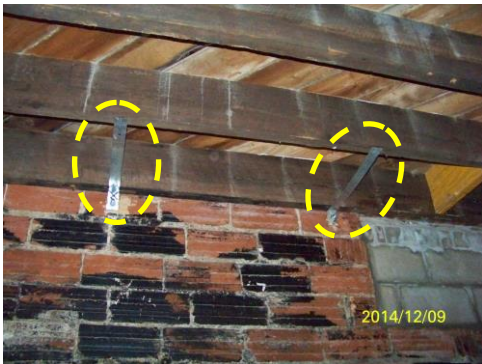
Photo showing tie-backs installed.

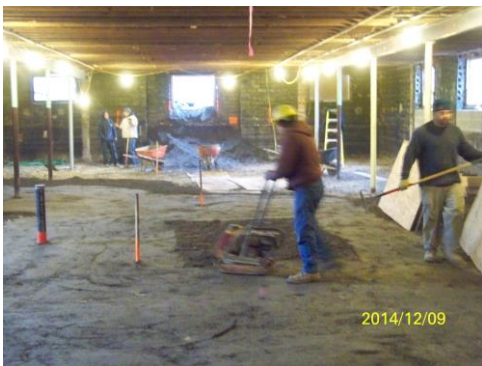
Photo showing workmen infilling the basement subfloor and compacting the fill.

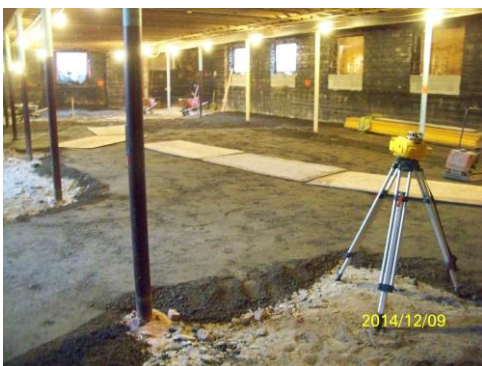
Photo showing backfilling and compaction towards the end of the work day.

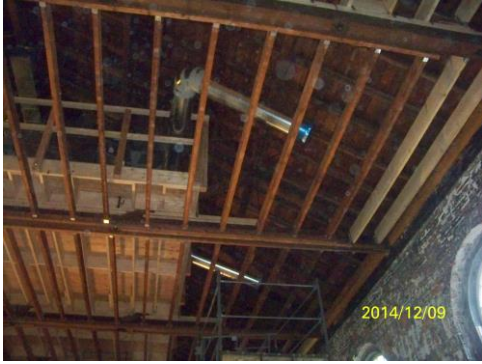
Photo showing ductwork installed along the north side of the attic.

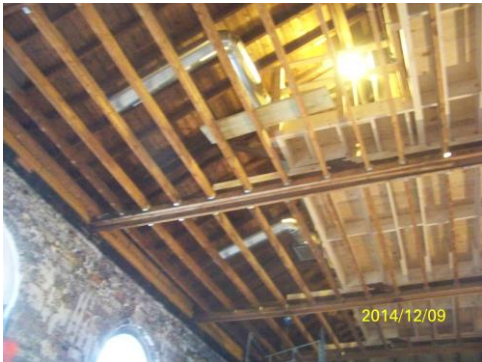
Photo showing ductwork installed along the south side of the attic.

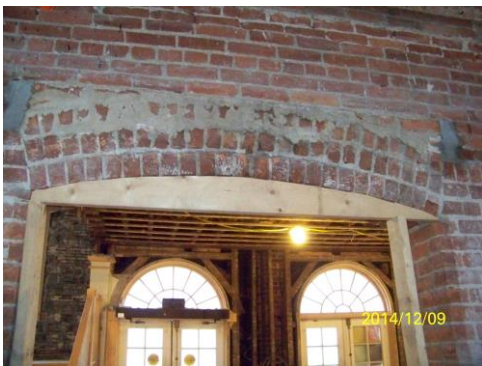
Photo showing formwork in place in order to repair one wythe of a fallen arch.
